## The Pegging Temperature Gauge Fix

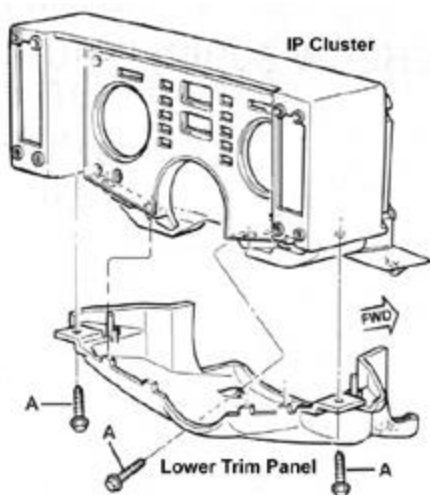
Figure 1

First you will need to remove the trim panel under the steering column. There are four 7mm screws, two of them screw into the bottom of the IP Cluster (Figure 1 - A screws). Next remove the two 10mm screws on the bottom of the IP Cluster (Figure 2 - C screws).

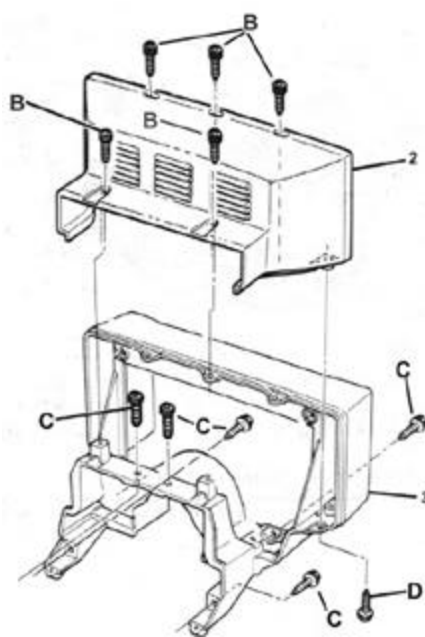
Figure 2

Next using a T-15 Torx bit, remove the five screws that hold the back trim panel of the IP Cluster, there are also two 7mm screws on the bottom of the IP Cluster (A total of 7 screws hold this panel on). (Figure 2 - A screws)

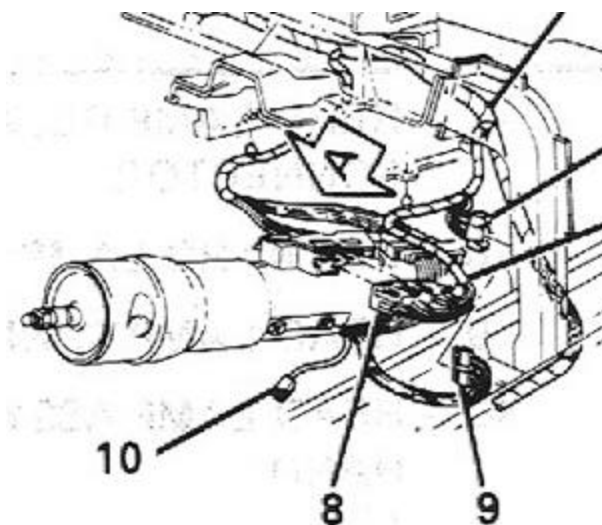
**Figure 3**  
(Number 8 is the Ignition Switch Connector)

Now you will be able to see a lot more. The first wire you need to get to is the Ignition Switch Connector. It is located on top of the steering column and is two pieces (Blue and Black connector) (Figure 3 - 8). This may be hidden by another larger flat connector (on the bottom of the steering column if you look from the bottom). You will barely be able to see the connector from the top, as it is hidden by the metal support for the steering column. Locate the two Light Green wires that are attached to the black portion of the connector (Figure 5 - G1)

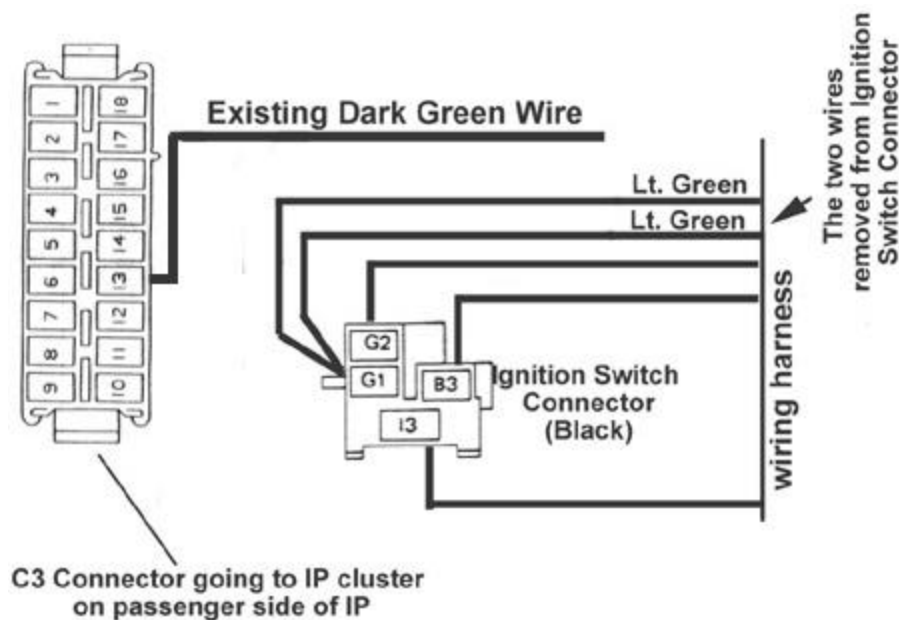
**Figure 6 Temp. Gauge Original Wiring**

The problem lies in the wiring...

**Now for the wiring fix**, you have two choices... Remove the terminal from the connector or cut the wires. (Note: The original Wiring is shown in Figure 6)
